FRACTURES OF THE SPINAL PILLAR

FRACTURES OF THE SCAPULAR BODY

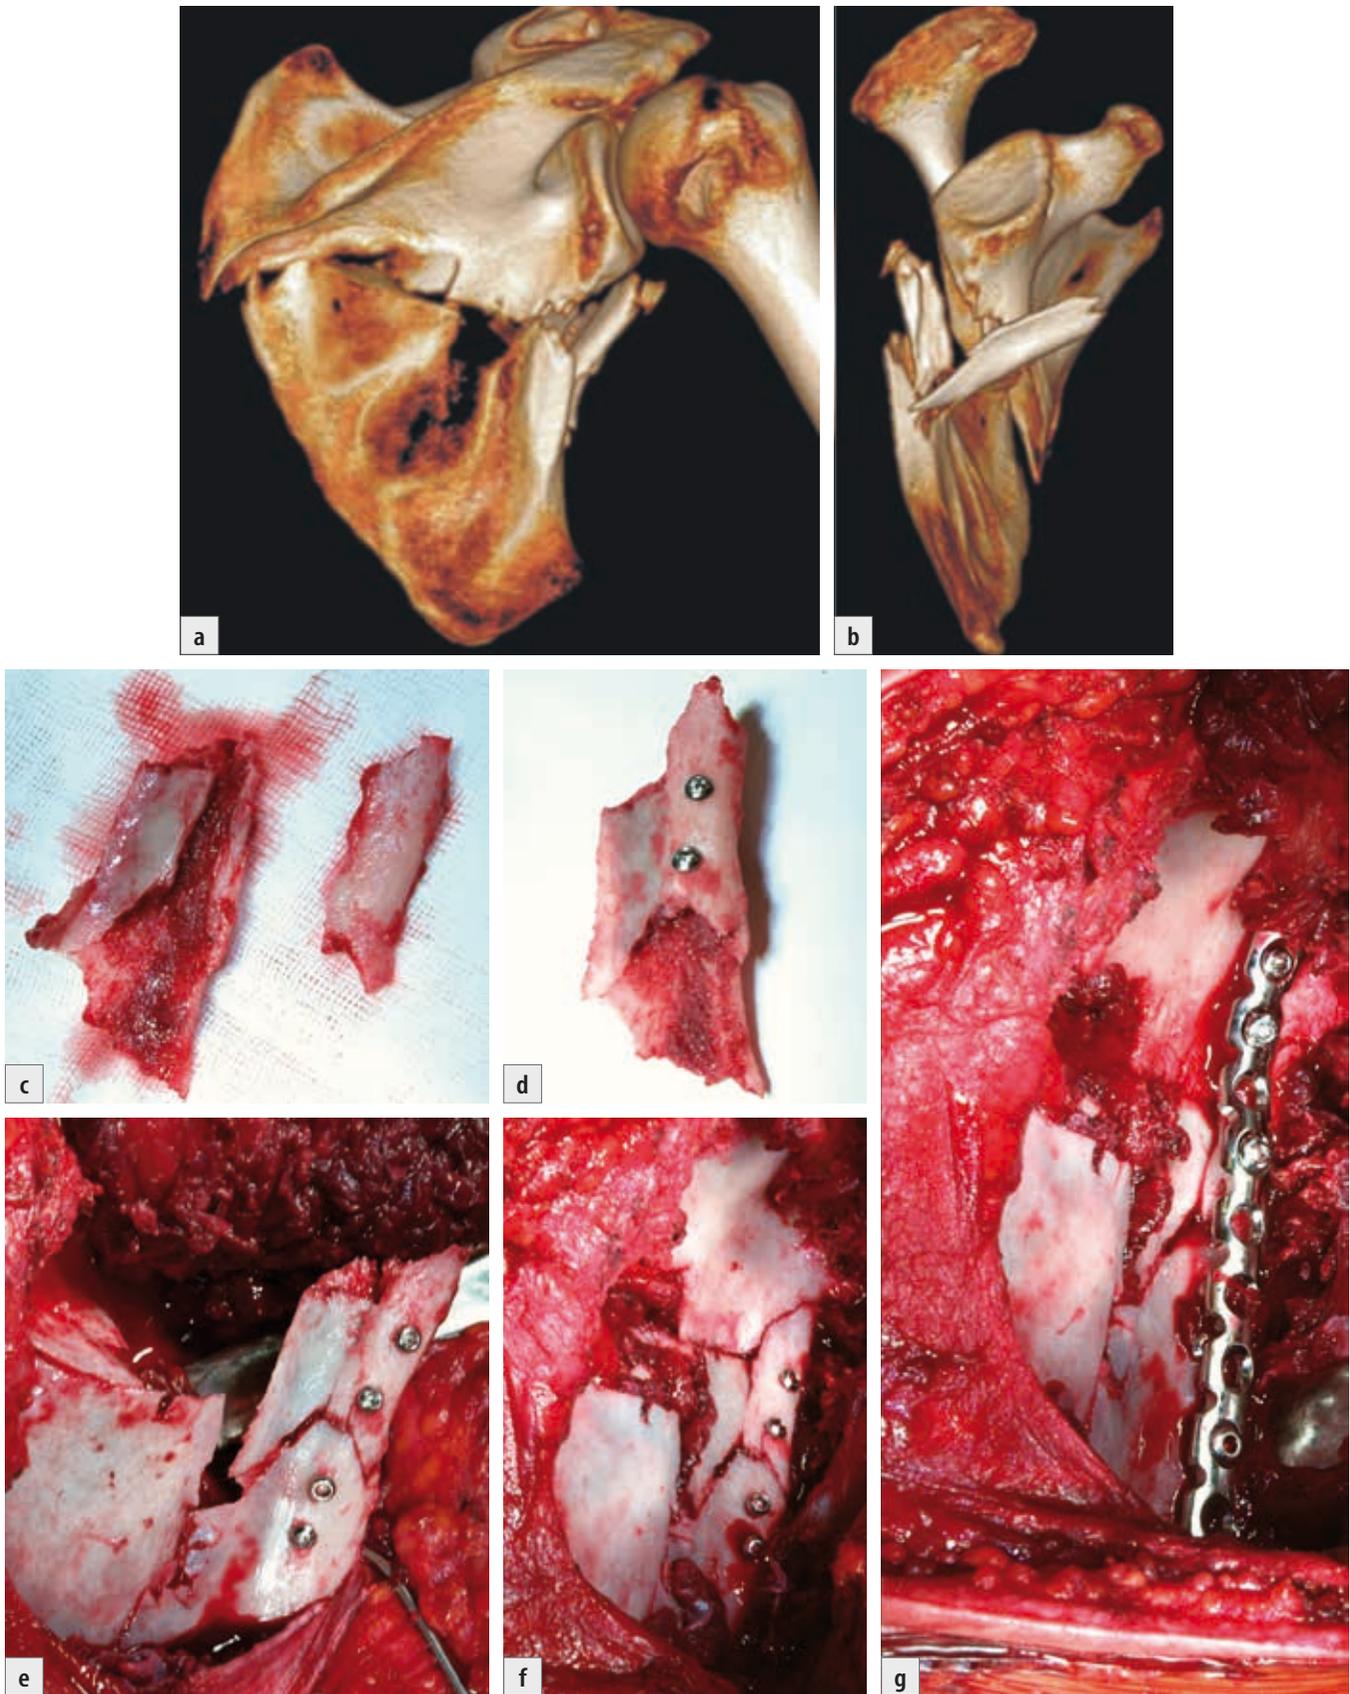
Fig. 11-8 Reduction and stabilization of a defective fracture of the lateral pillar of type 2b: **a)** a two-part infraspinous fracture of the scapular body; **b)** separation of a segment of the lateral pillar split longitudinally into two intermediate fragments; **c)** the two intermediate fragments; **d)** creation of one intermediate fragment using two 2.7-mm lag screws; **e)** fixation of the intermediate fragment to the distal fragment of the lateral pillar by two 2.7-mm lag screws; **f)** restoration of continuity of the lateral pillar; **g)** stabilization of the lateral pillar by a 3.5-mm reconstruction plate.

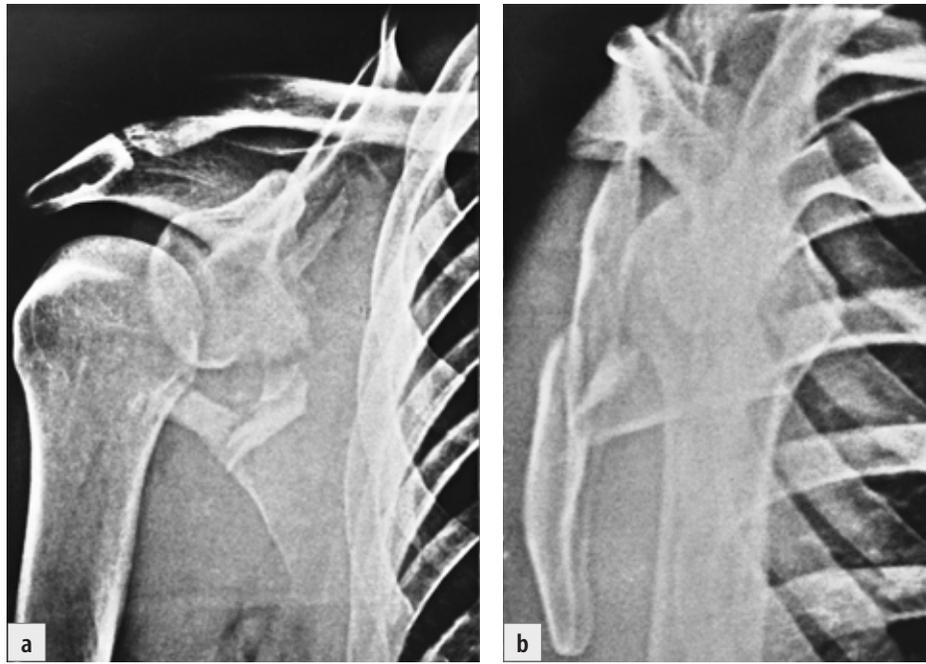
Fig. 12-1 Importance of 3D CT reconstructions for a proper determination of the fracture pattern: **a)** Neer I view; **b)** Neer II view; **c+d+e)** CT transverse sections at the level of the infraspinous fossa; **f)** 3D CT reconstruction, anterior view; **g)** 3D CT reconstruction, posterior view; **h)** 3D CT reconstruction, posterolateral view with subtraction of the humeral head. Only 3D CT reconstructions show that it is a two-part fracture of the infraspinous part of the scapular body, with two intermediate fragments separated from the lateral pillar.

An exact determination of a scapular body fracture, or its pattern, based on radiographs alone is extremely difficult, if not impossible. Many two-part infraspinous fractures of the scapular body have been interpreted, on the basis of radiographs alone, as fractures of the surgical neck of the scapula. Scapular body fractures can be reliably specified only by means of 3D CT reconstructions (**Fig. 12-1**) [7, 39], not only with the view of the anterior aspect, but, more importantly, of the posterior aspect, which shows the course of the fracture lines in relation to the scapular spine.
