Fig. 16-7 Images of a complex extraarticular fracture of the scapula: **a)** 3D CT reconstruction without subtraction of the surrounding bones; **b)** semitransparent 3D CT reconstruction; **c)** subtraction of the surrounding bones.

TREATMENT

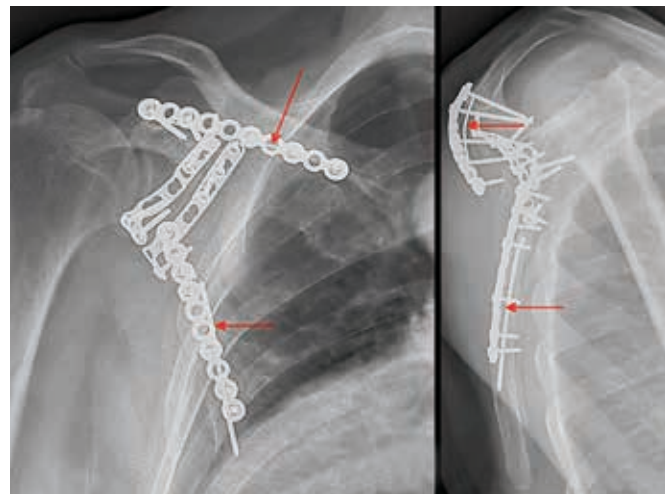
Fig. 16-8 The technique of a lost K-wire (red arrows) used to reconstruct both pillars of the scapula in a fracture shown in Fig. 16-7.

Operative technique: The first step consists in a careful removal of the early callus, especially if the operation is performed several weeks after the injury, and identification of individual fragments. The fracture surfaces are cleaned and reduced. Reduction techniques have been described in Chapter 11. The technique of a lost K-wire has proven successful for the maintenance of temporary reduction, especially in fractures of both pillars [2] (**Fig. 16-8**). Internal fixation is usually performed using 2.7-mm implants.

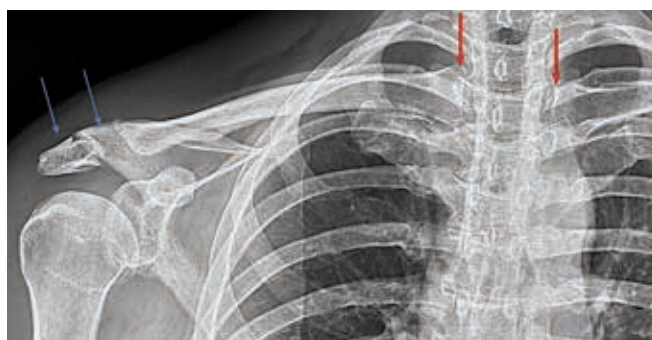
Fig. 17-1 Fracture of the right acromion associated with AC dislocation (blue arrows) and anterior SC dislocation on the same side (red arrows).

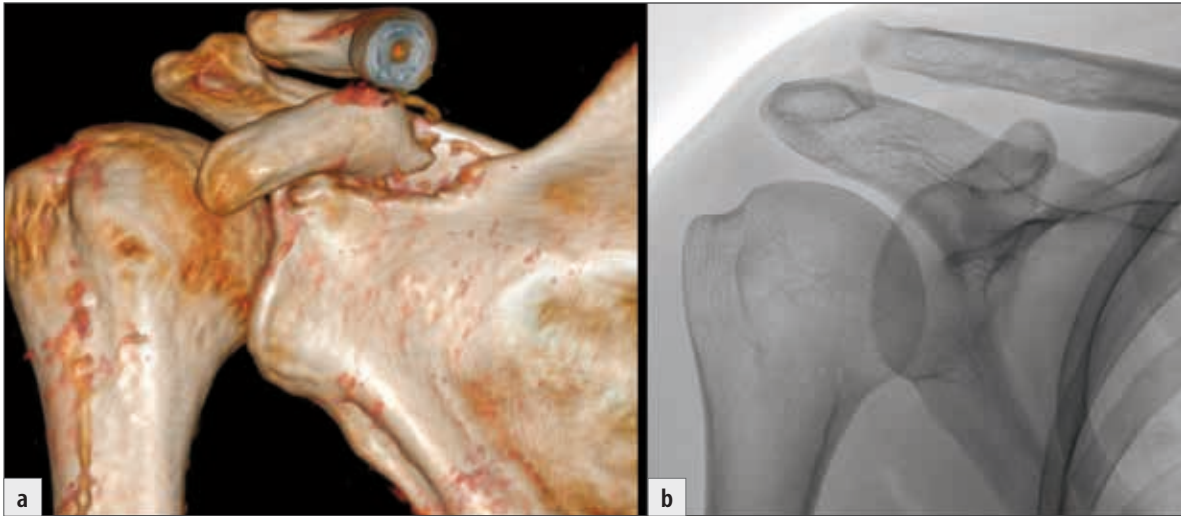
Fig. 17-6 Osseous extraarticular AC instability associated with a coracoid base fracture: **a)** 3D CT reconstruction; **b)** radiograph.

The first “*osseous*” variant is characterized by an intact coracoclavicular ligament and extraarticular (Fig. 17-6), or intra-articular (Fig. 17-7) separation of the coracoid base (primarily fractures of the superior glenoid).

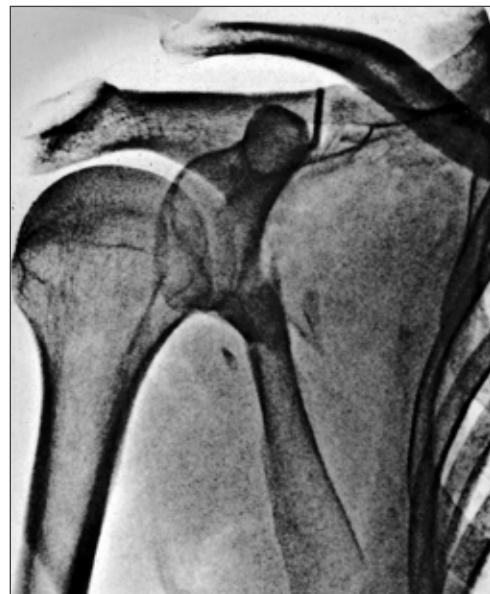
Fig. 17-8 Ligamentous instability of AC joint in a three-part infraspinous fracture of the scapular body.

In the other, “*ligamentous*”, variant, the coracoclavicular ligament is ruptured and the coracoid remains intact (Fig. 17-8). Rarely, the two variants may combine (Fig. 17-9) [59, 61].

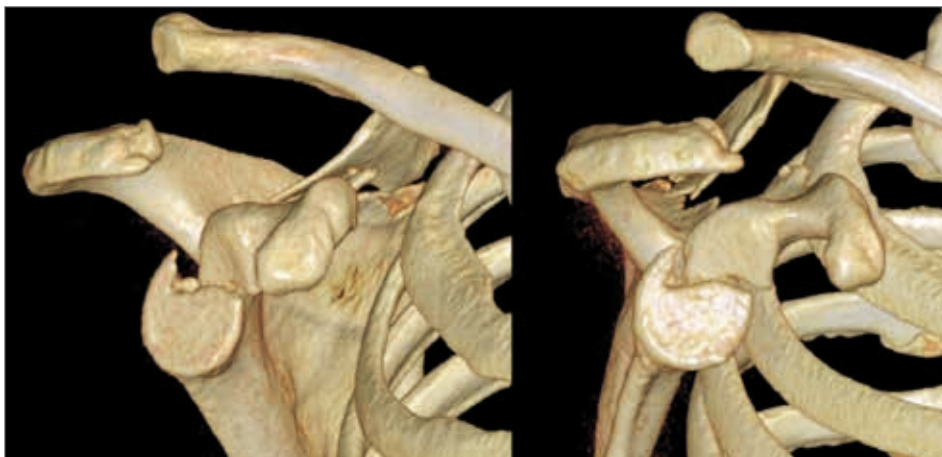
Fig. 17-9 Combined AC instability in a fracture of the superior glenoid associated with rupture of the coracoclavicular ligament on 3D CT reconstructions. From the archives of J. Letocha, MD.

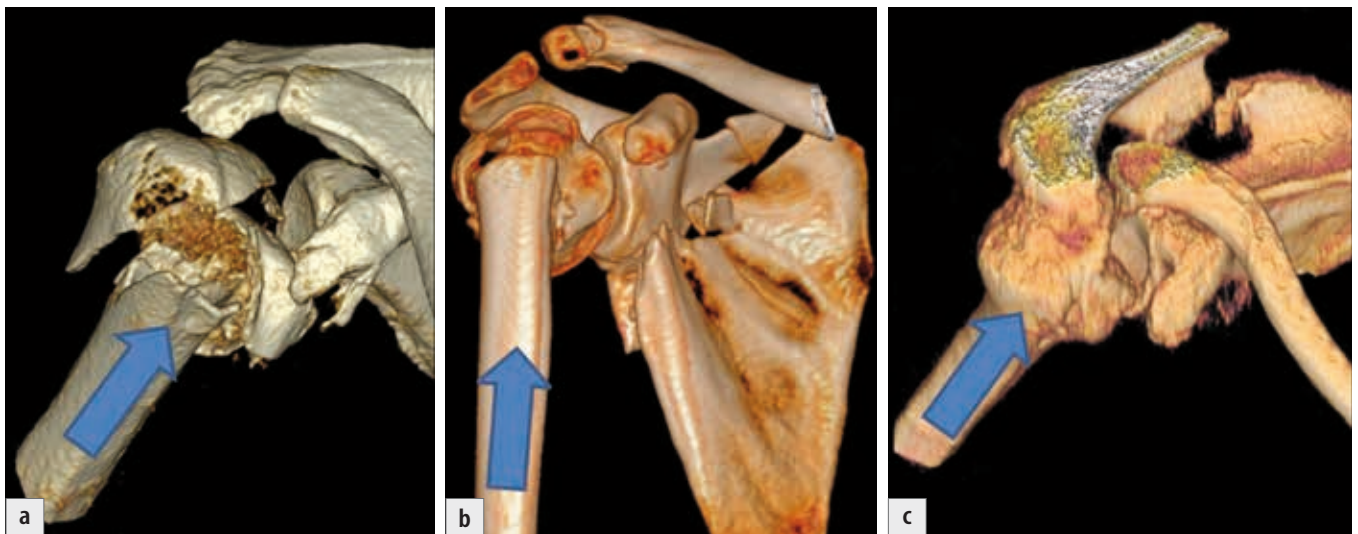
Fig. 17-29 The effect of direction of displacement of the humeral head on injury to the surrounding structures of the scapula: **a)** anterior and proximal displacement results in injury to the anterior rim of the glenoid and the coracoid; **b)** proximal displacement causes injury to the AC joint or the lateral clavicle; **c)** proximal and posterior displacement results in injury to the acromion, or the lateral part of the scapular spine.

In both groups, particularly the second, it is the humeral head which is responsible for the injury to the scapula. Injuries to the surrounding structures depend on the direction of displacement of the humeral head (Fig. 17-29).
