ATLAS

A TWO-PILLAR FRACTURE OF THE SCAPULAR BODY

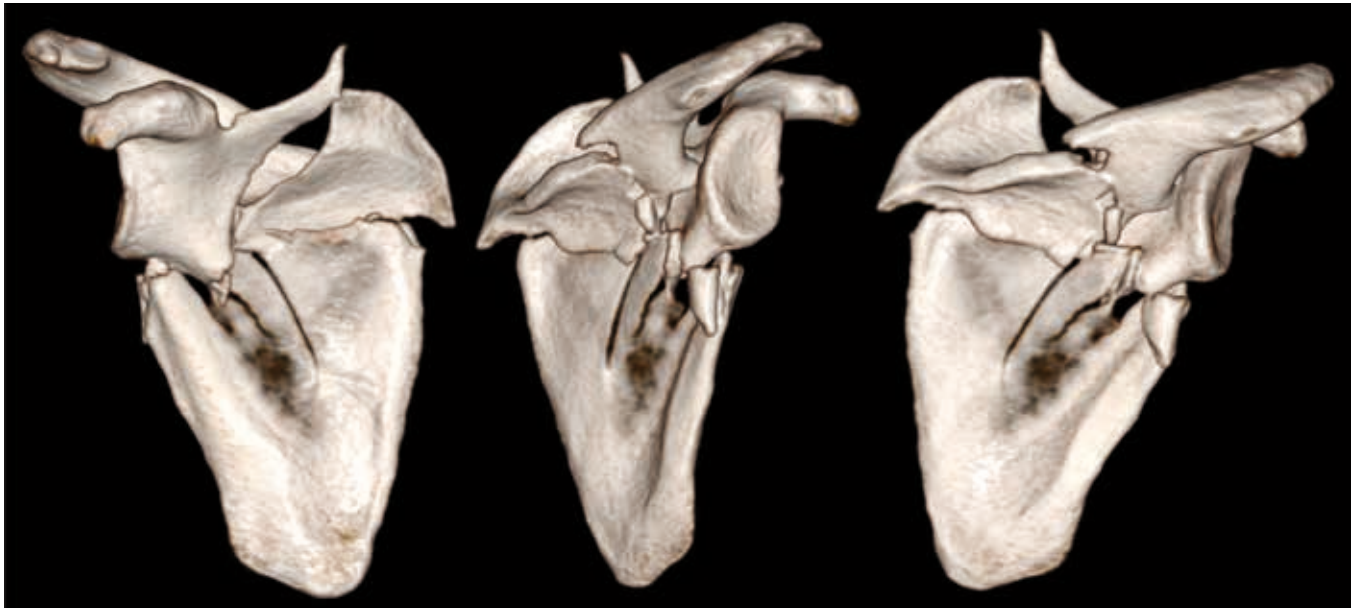
Fig. 1 Fracture anatomy on 3D CT reconstructions.

Note: This fracture was classified as a two-pillar fracture of the scapular body because the glenoid fragment carried the coracoid as well as the lateral scapular spine, although this cannot be clearly seen on 3D CT reconstructions. Reduction and internal fixation did not require mobilization of the infraspinatus, but merely its retraction. In this case, internal fixation with 2.7-mm implants provided adequate stability.

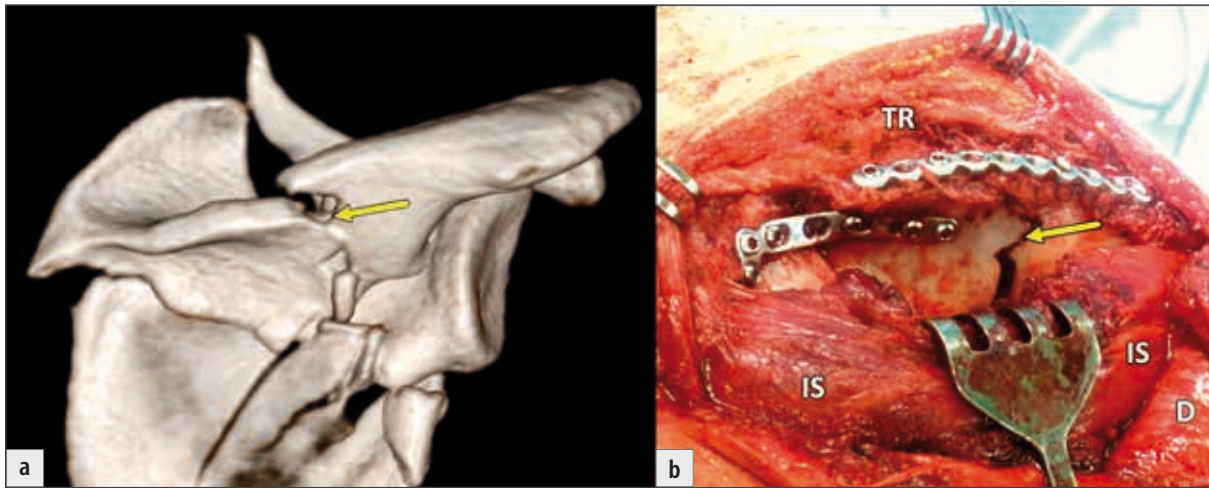
Fig. 3 Reconstruction of the scapular spine (spinal pillar): **a)** 3D CT reconstruction of the fracture from the posterior view; **b)** reduction and internal fixation with two plates. D – deltoid, IS – infraspinatus, TR – trapezius. Yellow arrow – the fracture line passing through the central weakened part of the scapular spine.

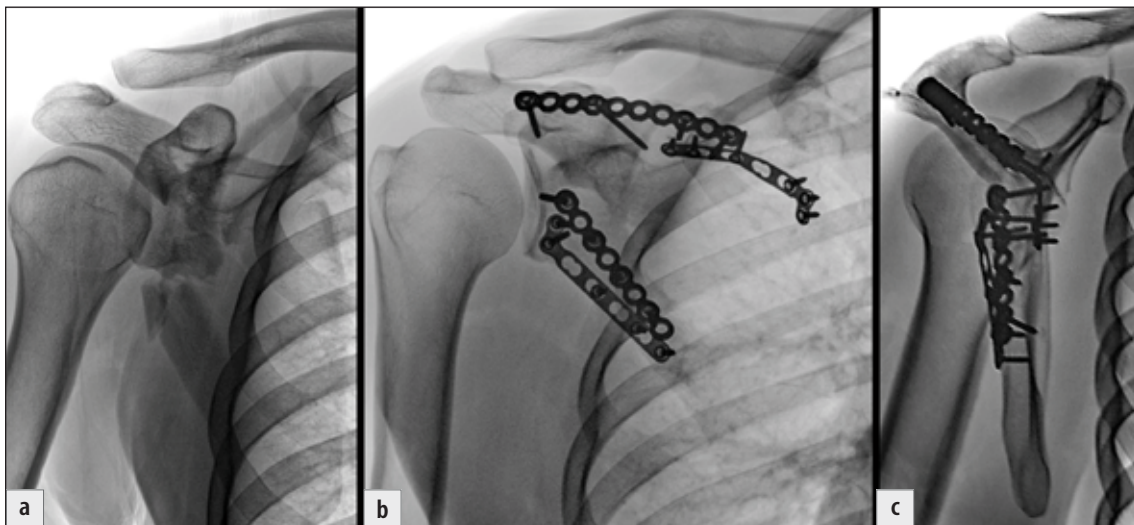
Fig. 4 Radiological follow-up: **a)** post-injury radiograph; **b+c)** postoperative radiographs.

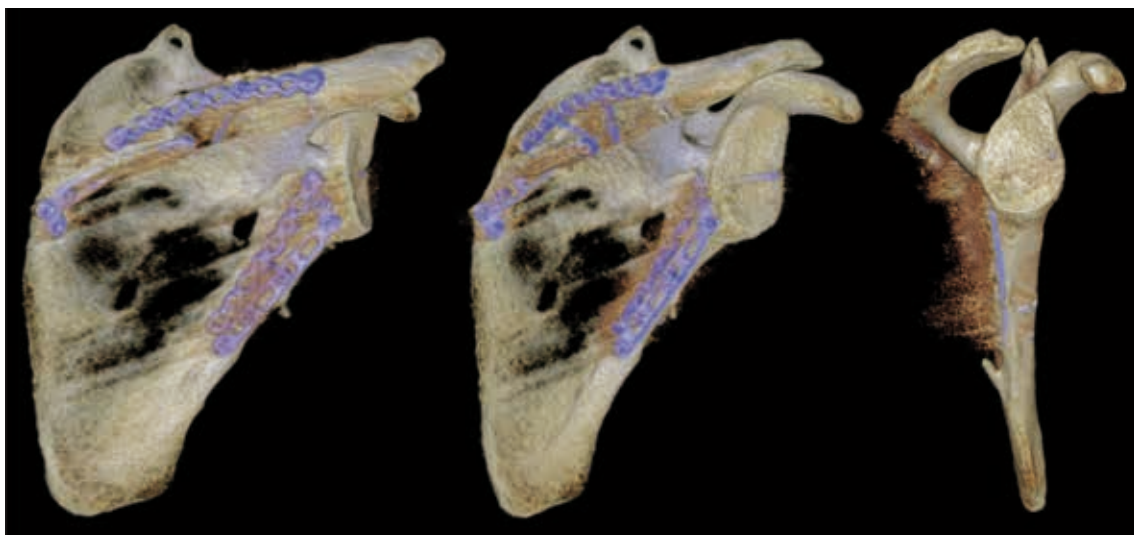
Fig. 5 Follow-up 3D CT reconstructions 5 years postoperatively.

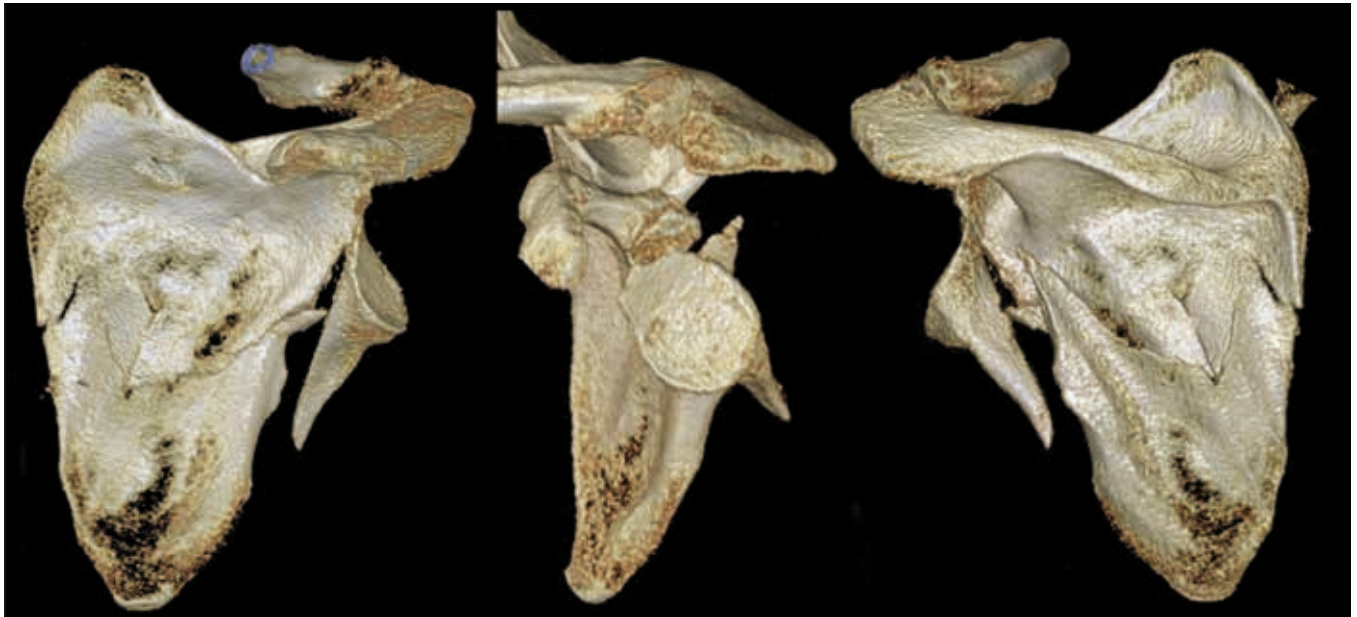
Fig. 1 Fracture anatomy on 3D CT reconstructions.

Note: In this case the fracture line passed through the superior rim of the articular surface, which resulted, probably due to the poor bone quality, in separation of a small intermediate fragment. Therefore, it cannot be stated definitively whether it was still a fracture of the anatomical neck, or already a glenoid fracture. Infraspinous fracture of the scapular body in some cases accompanies fracture of the anatomical neck.

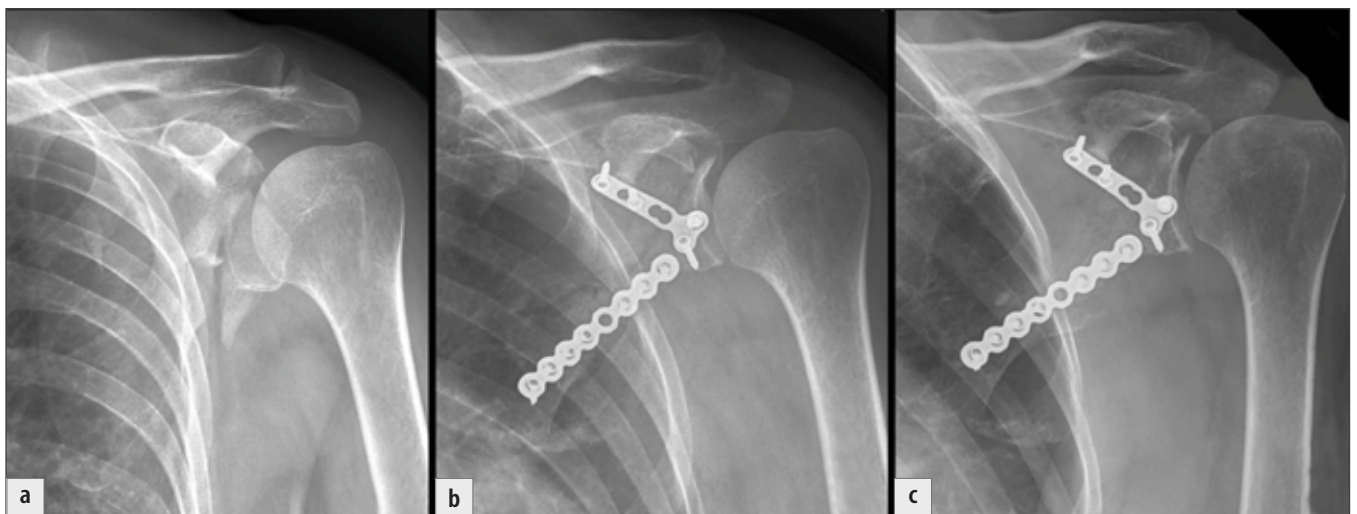
Fig. 2 Radiological outcome of the operation: **a)** post-injury radiograph; **b)** postoperative radiograph; **c)** 1 year postoperatively.

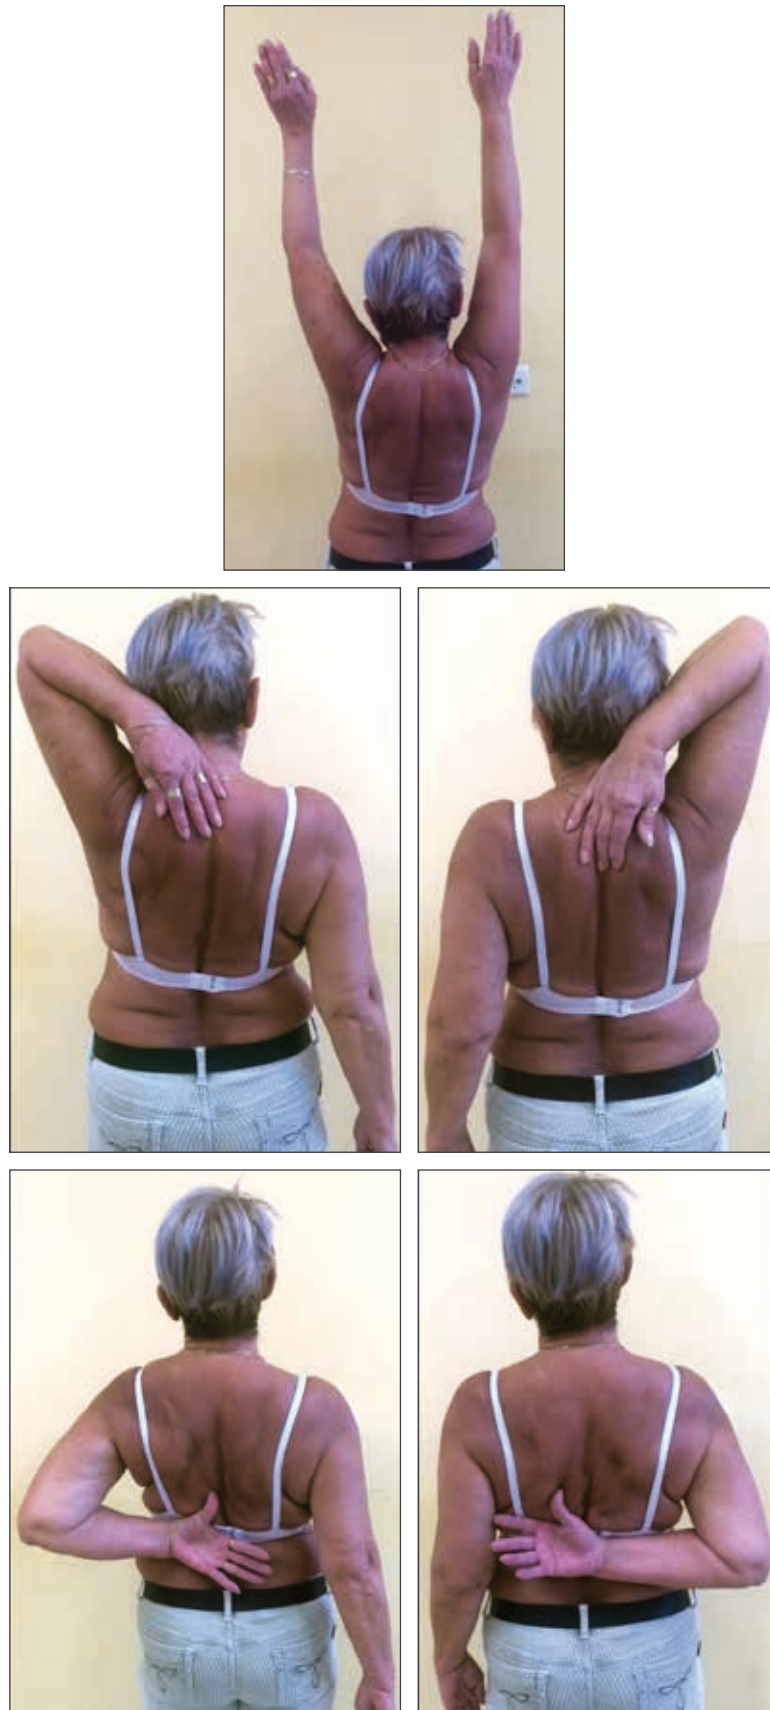
Fig. 3 Functional outcome 1 year postoperatively. It is evident, that even severe fractures, such as this one, may also be treated operatively in older patients, with an excellent functional outcome.

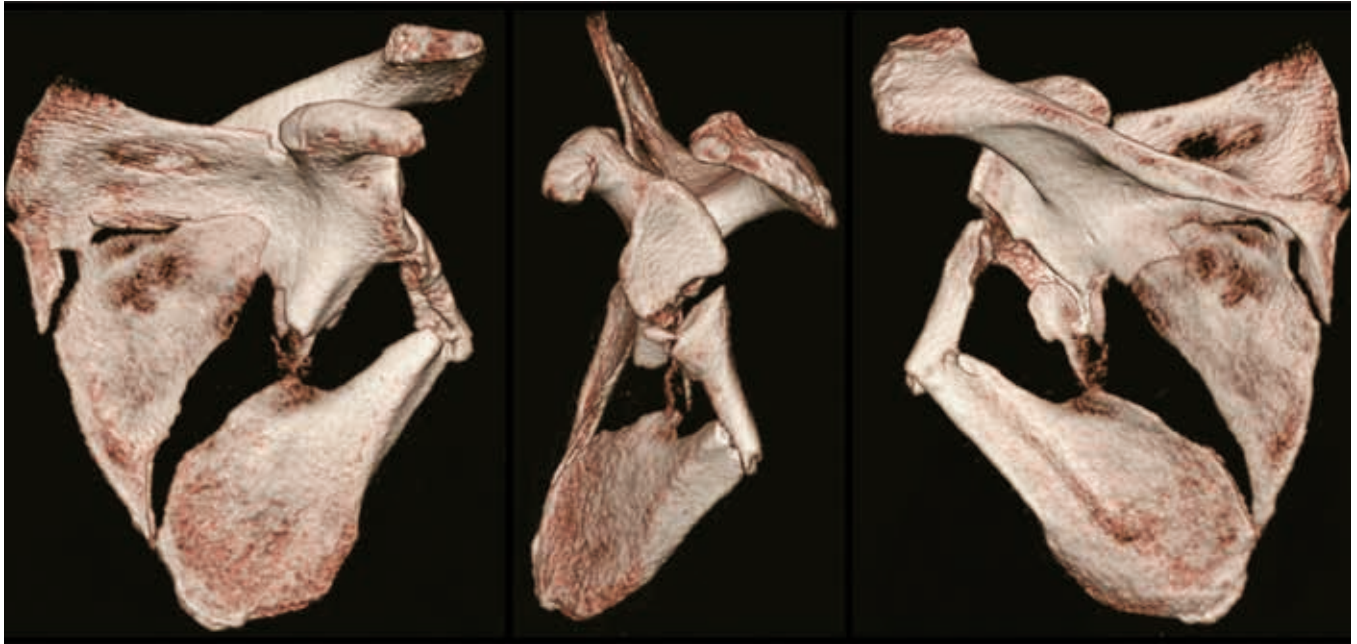
Fig. 1 Fracture anatomy on 3D CT reconstructions.

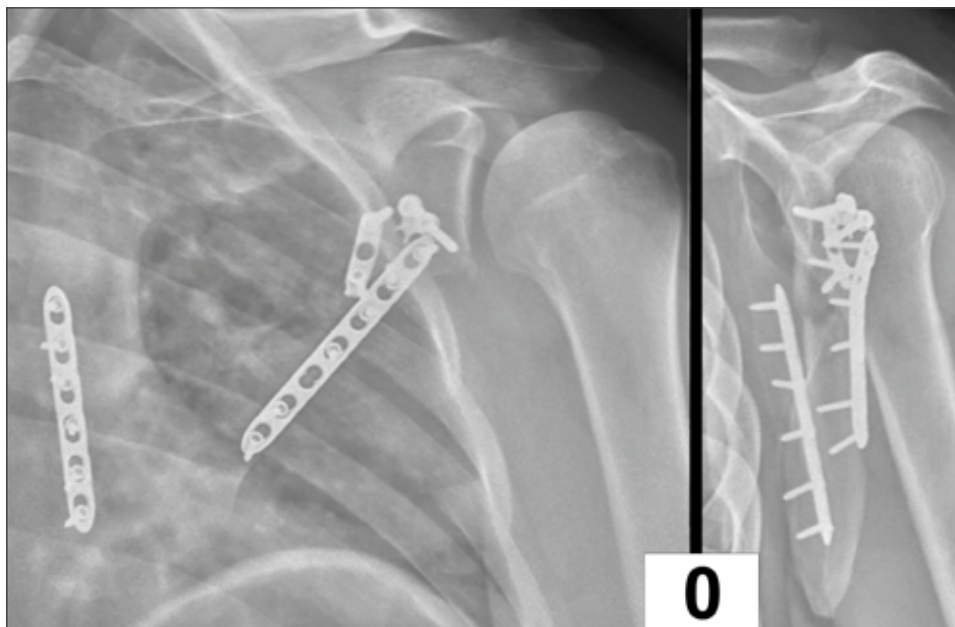
Fig. 2 Postoperative radiographs.

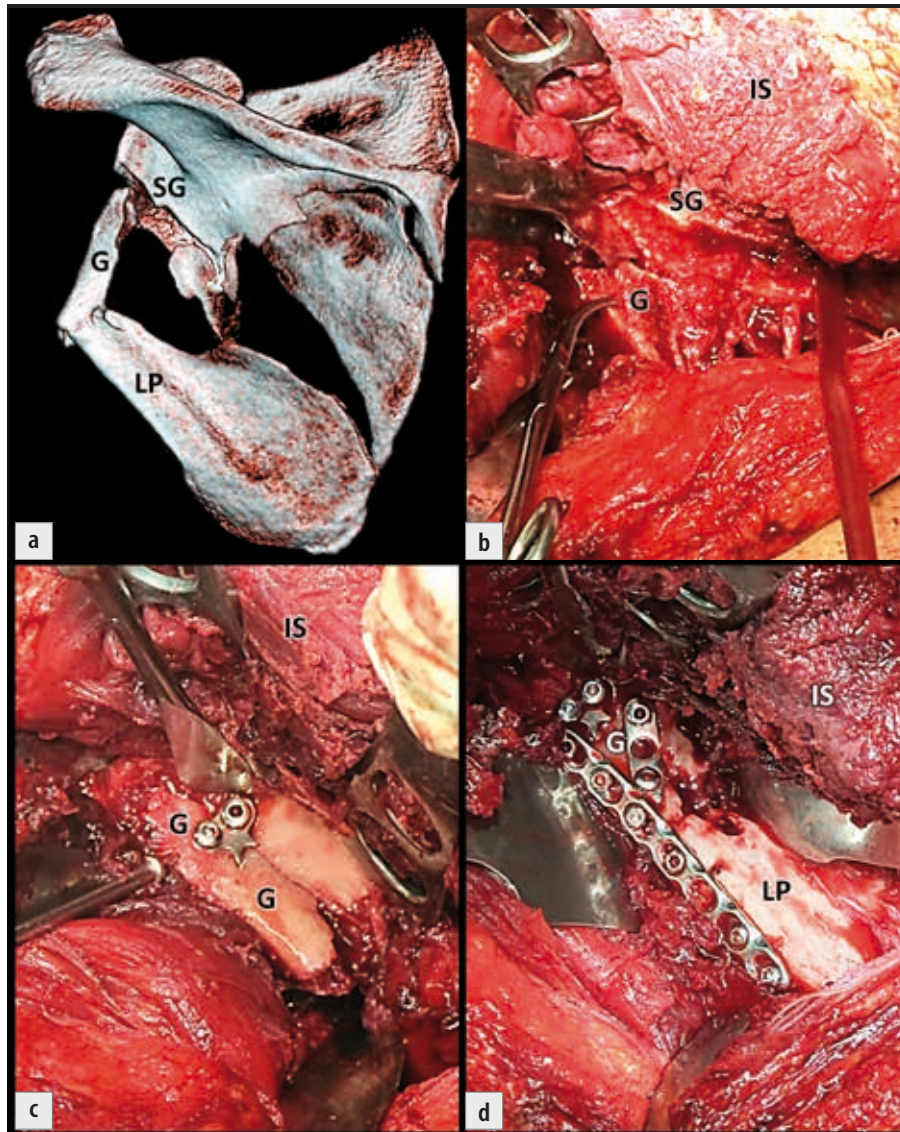
Fig. 3 The course of reconstruction: **a)** 3D CT reconstruction, posterior view; **b)** intraoperative finding after debridement of individual fragments; **c)** reduction and fixation of the inferior glenoid fragment; **d)** completed internal fixation. G – inferior glenoid fragment, IS – infraspinatus, LP – fragment of the lateral pillar, SG – spinoglenoid notch.

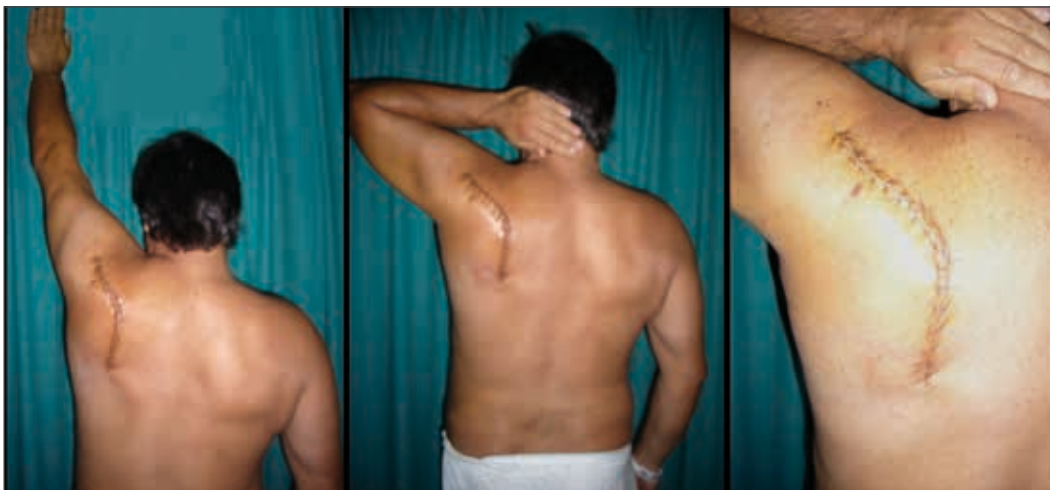
Fig. 4 Active range of motion one week postoperatively.

Note: This case documents the effect of the extent of the surgical approach on the speed of restoration of the range of motion. The infraspinatus was not reflected, merely retracted, during operation.

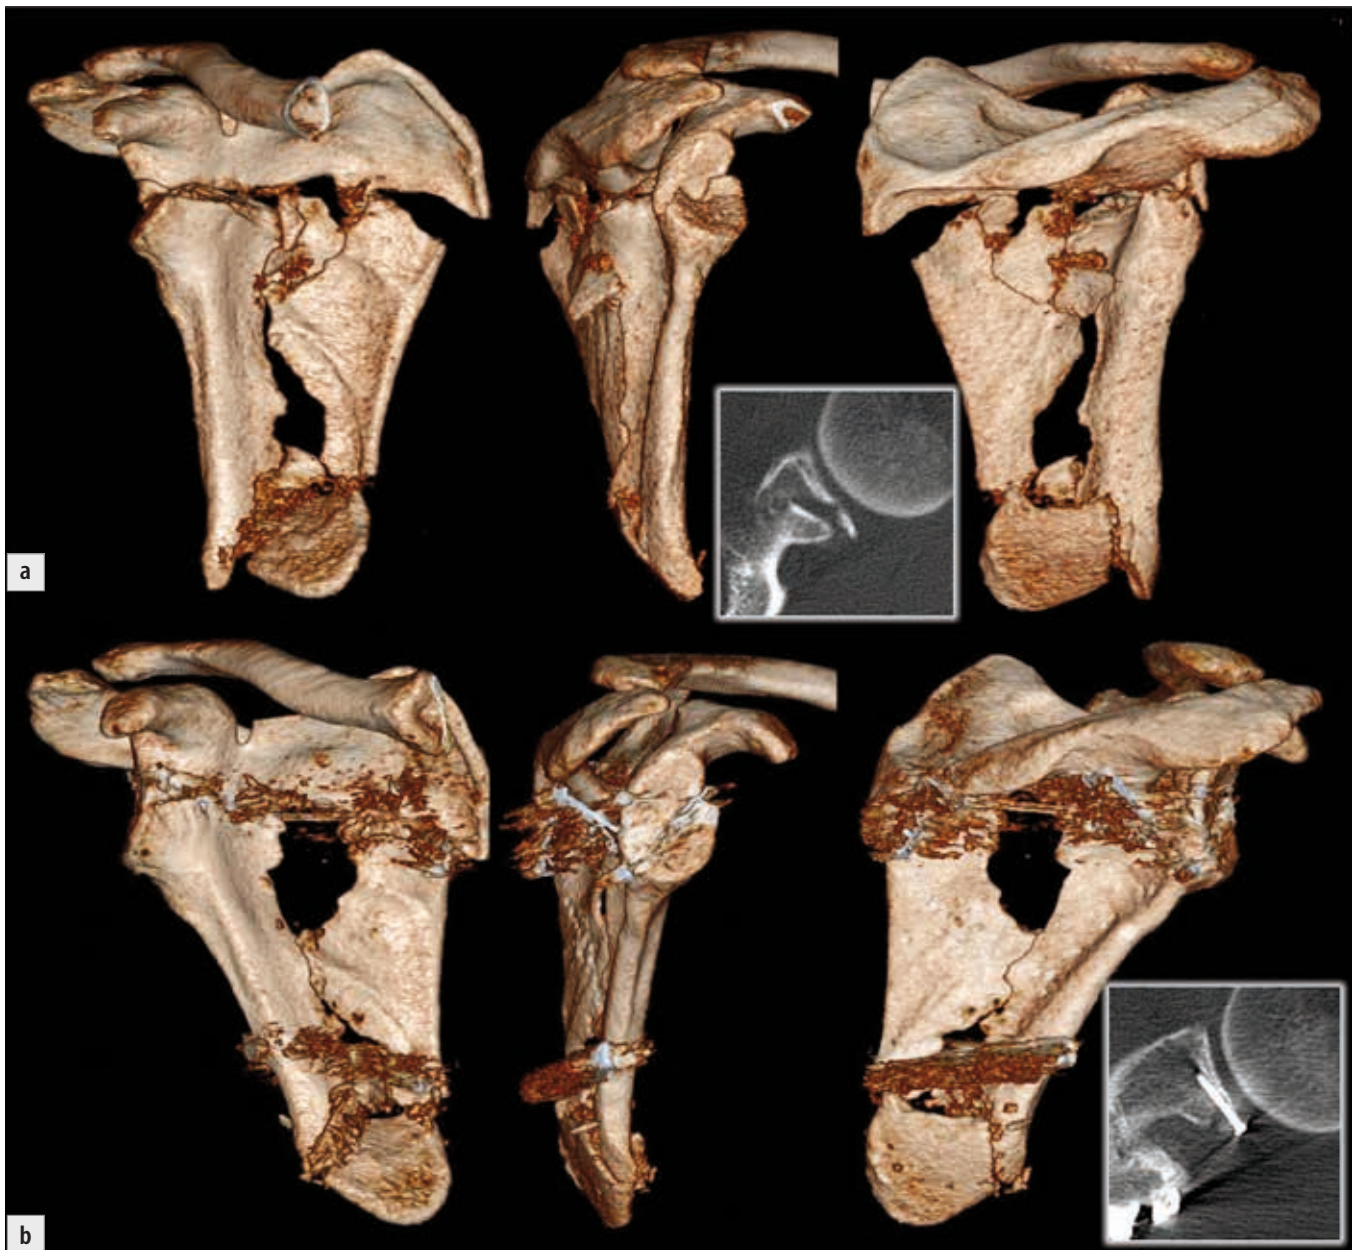
Fig. 1 The fracture on 3D CT reconstructions: **a)** before operation; **b)** after operation.

Note: This patient was operated on as late as 30 days after the injury because other clinical units had recommended non-operative treatment. The operation took almost 4 hours; despite atrophy of the infraspinatus, the functional result has been assessed both subjectively and objectively as excellent.
