A TOTAL GLENOID FRACTURE SEPARATED ALONG THE LINE OF THE ANATOMICAL NECK AND ASSOCIATED WITH A FISSURE OF THE INFRASPINOUS PART OF THE SCAPULAR BODY

A COMPLEX INTRAARTICULAR FRACTURE

A COMPLEX INTRAARTICULAR FRACTURE OF THE SCAPULA

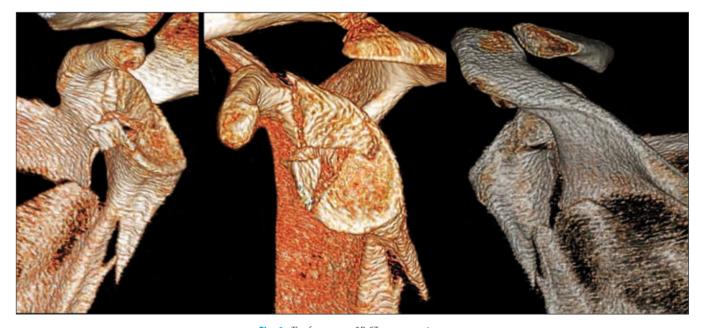
Fig. 1 The fracture on 3D CT reconstructions.

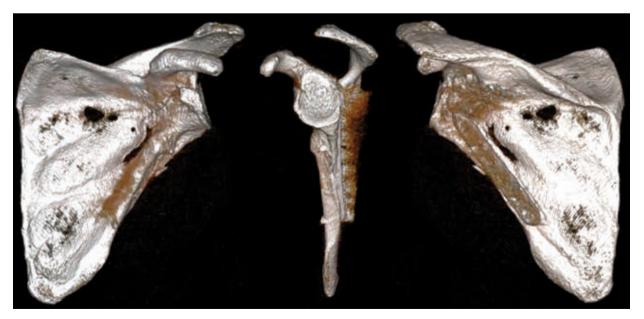
Fig. 5 Postoperative 3D CT reconstruction of the scapula.

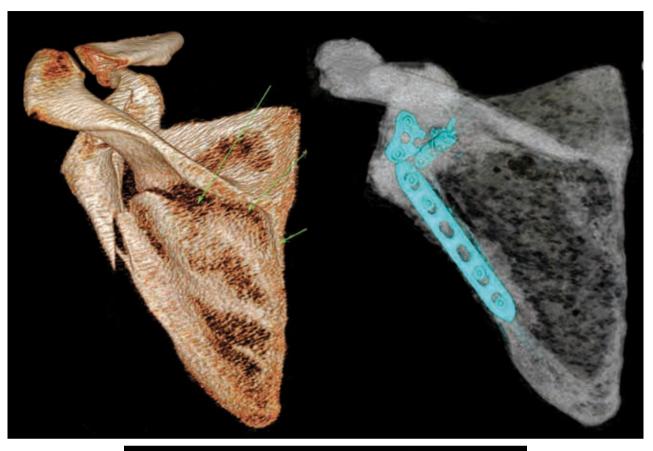
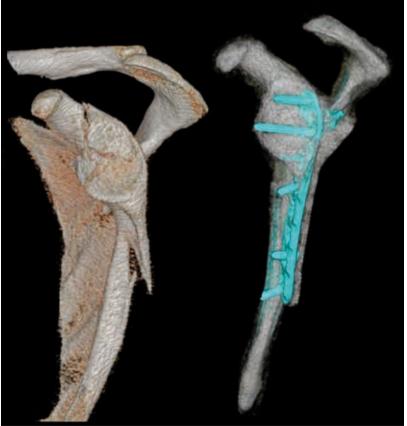
Fig. 6 The 2-year outcome of operation on comparative pre- and postoperative 3D CT reconstructions of the scapula. Green arrows show the course of the fracture line to the spinomedial angle.

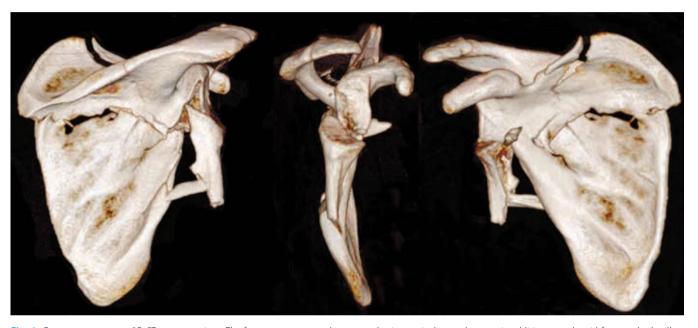
Fig. 1 Fracture anatomy on 3D CT reconstructions. The fracture was assessed as a complex intraarticular one because in addition to a glenoid fracture, both pillars were damaged.
